NASA/CR-2001-211025

Development and Evaluation of Stitched Sandwich Panels

*Larry E. Stanley and Daniel O. Adams
University of Utah, Salt Lake City, Utah*

June 2001

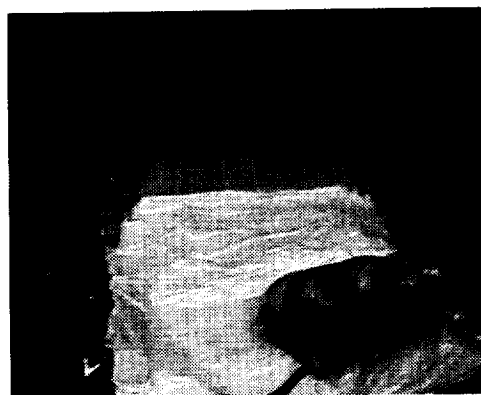
a. Beginning of Infiltration.

b. Midpoint of Infiltration.

c. Close-up view of Infiltration.

d. Fully Infiltrated.

Figure 3.8 VARTM Infiltration Process

After the resin and hardener were mixed, the resin inlet tube was placed into the resin pot and the vacuum pump was turned on. Resin was pulled through the tube and into the vacuum bagged panel assembly, infiltrating the facesheets as well as the Kevlar stitches as shown in Figures 3.8a through 3.8d. The through-the-thickness stitching produced resin paths that allow resin to flow freely between the top and bottom facesheets of the panel. Thus, the facesheets were infiltrated and bonded to the core in the same processing step.

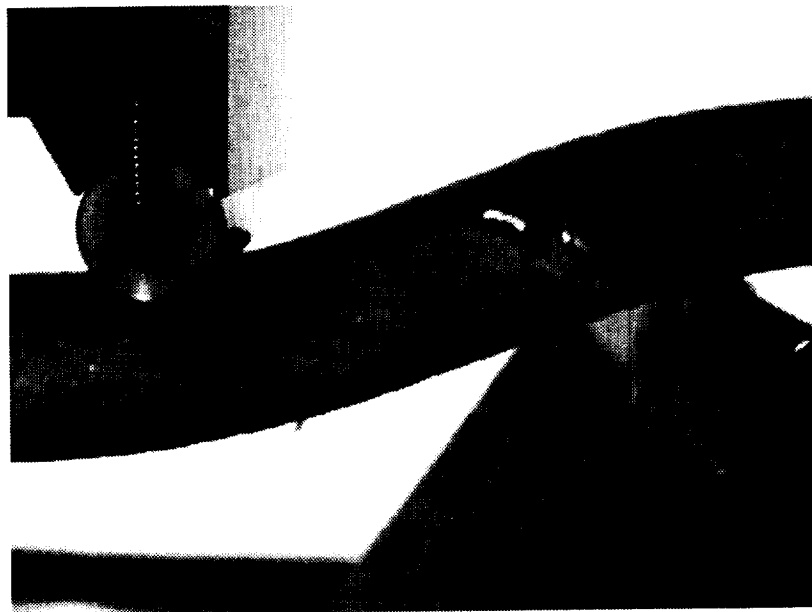
Figure 5.5 Initial failure in stitched Utah specimen in four-point flexure loading.

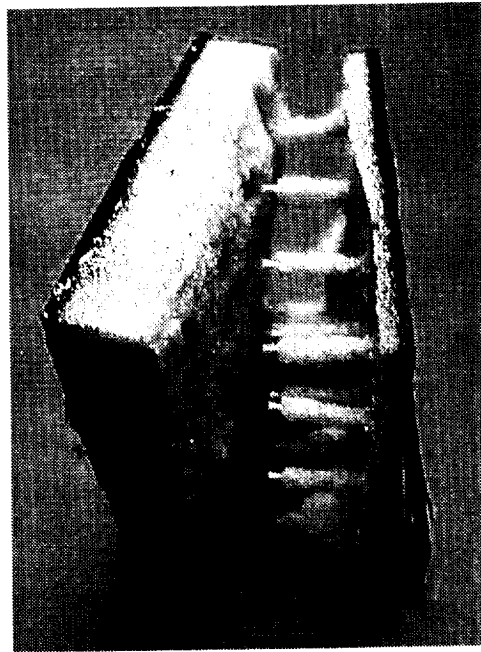
Figure 5.16. Failed Utah specimen stitched with 400 denier bobbin thread.

The average value of the maximum load recorded was 775 lbs, corresponding to a maximum tensile stress of 194 psi. Thus, only a 4% increase in tensile strength was obtained by stitching when the smaller bobbin thread was used. Based on the tensile strength of infiltrated yarns reported in Chapter 4, a flatwise tensile strength of 2032 lbs. was predicted for these specimens. Thus, only 38% of the predicted flatwise tensile strength was obtained in these specimens. As shown in Table 5.5, the difference between the initial failure load and the maximum load was only 3% for these specimens. Upon inspection of the failed specimens, it was determined that the smaller bobbin thread failed at the intersection with the thicker stitch thread, leaving the stitch loop intact. Following failure of the bobbin thread, the resin-infiltrated stitched pulled out of the surrounding foam core, leaving the stitch column intact as shown in Figure 5.16.

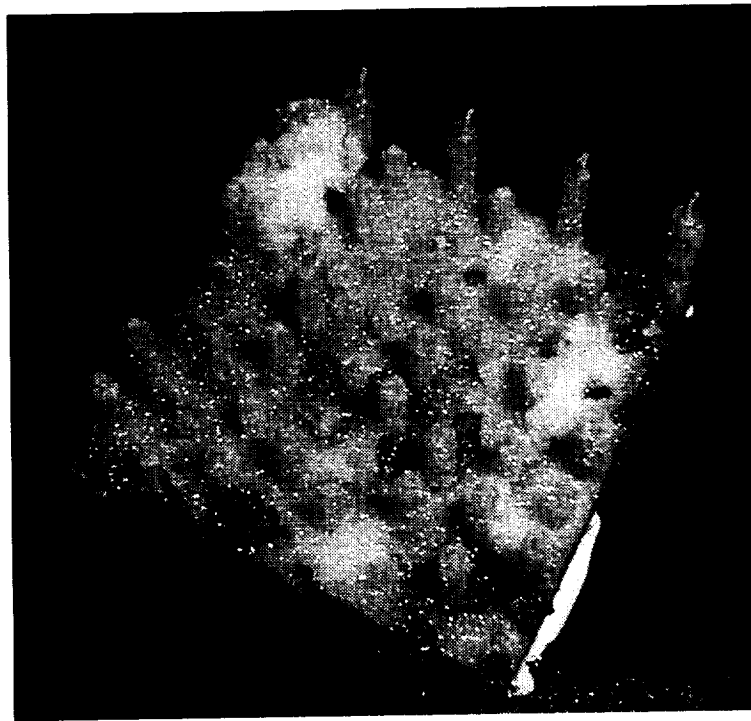
Figure 5.22 Failed NASA specimen with 1.0 in. core and 0.25 in. stitch spacing.

Further differences between the Utah and NASA panels were observed when inspecting the failed flatwise tensile specimens. In the Utah specimens, which had a single layer of warp-knit fabric in each face sheet, the stitches nearly always failed at the intersection between the stitch loop and the bobbin thread as discussed previously. In the NASA specimens, the stitches rarely failed at this location. As shown in Figure 5.21, approximately one-half the stitches failed at the interface between the face sheet and core. A majority of the remaining stitches failed at other locations within the core. A small number of stitches, usually at the edges of the specimen, still failed at the stitch loop/bobbin connection as shown in Figure 5.22.

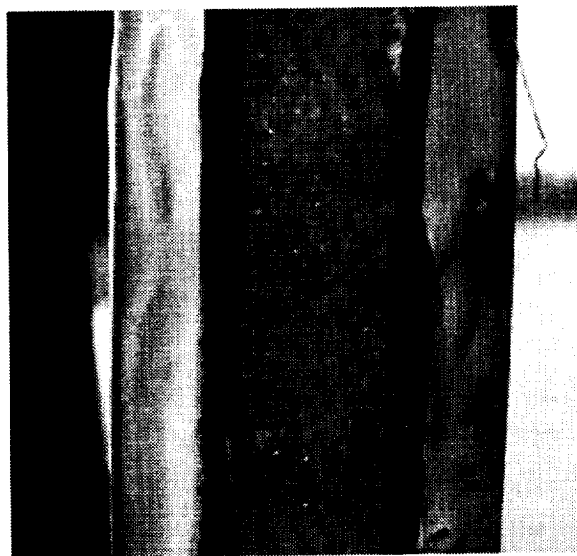
Figure 2.26 Initial failure of stitched specimen during core shear testing.

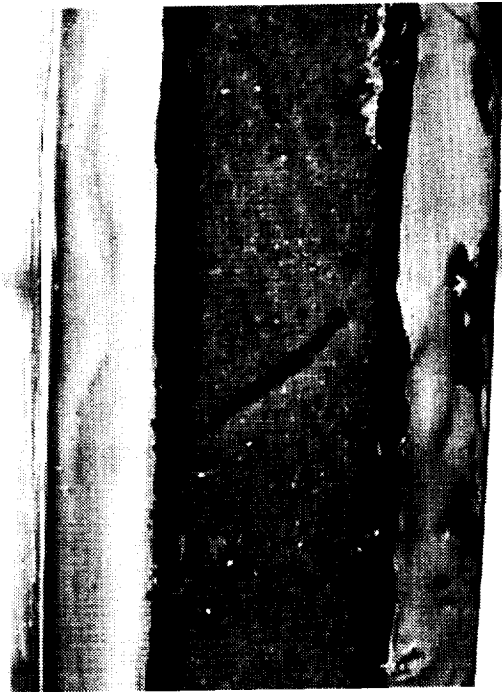
Figure 5.27 Widening of core crack under increasing loading for stitched specimen
